INCIDENT NO: 549337 JIV report S/N:  
JOINT INVESTIGATION REPORT<sup>1</sup>

1. Fountain Incident Number: 549337 2. Type of incident<sup>2</sup> OIL SPILL  
3. Name of Location 28" BOMU - BONNY PIPELINE  
4. Name of nearest community BODO 5. State: RIVERS 6. LGA GOKANA  
7. Production Facility/Installation OIL PIPELINE  
8. Asset Owner/Hub THE SHELL PETROLEUM DEVELOPMENT COMPANY OF NIGERIA LTD (SPDC)/PIPELINE

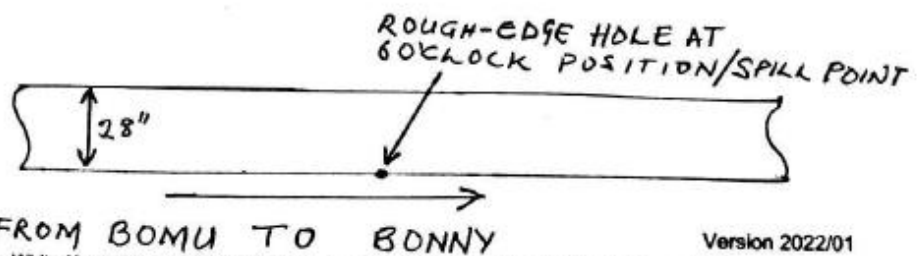
**E. GRAPHIC DESCRIPTION OF LEAK POINT** (while detail report of the leak point should be contained in the leak report, overview sketch of the site should be added as an appendix 1) A SECTION OF 28" BOMU - BONNY PIPELINE AT BODO SHOWING ROUGH-EDGE HOLE AT 6 O'CLOCK POSITION, DUE TO EQUIPMENT FAILURE.
